## Use of Photogrammetry and Terrestrial Laser Scanning to Measure Superficial Weathering Damage on the Façade of Hanfelden Castle, Austria

JOURNAL OF MEDITERRANEAN CITIES (2023), 3(1), 01-19

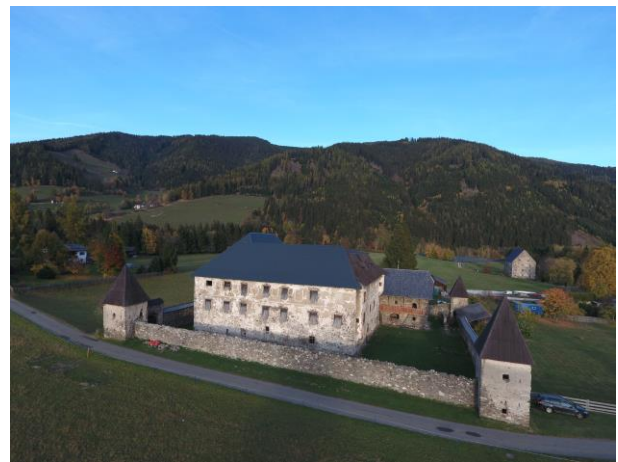
**Figure 2.** Perspective view from West (Photo Sulzer 2019)

What particularly distinguishes Hanfelden castle is its unadulterated, authentic appearance (fig. 2). This is due to the fact that no major changes have been made to the building for around 250 years and that it largely corresponds optically to the oldest known depiction by G. M. Vischer from 1681 (fig. 3). Fig. 4 represents the castle from the year 1830, where baroque ornaments are visible, which are partially still now on the façade. The castle was placed under monument protection in 1965 and is conscientiously looked after by the Federal Monuments Office (Bundesdenkmalamt).

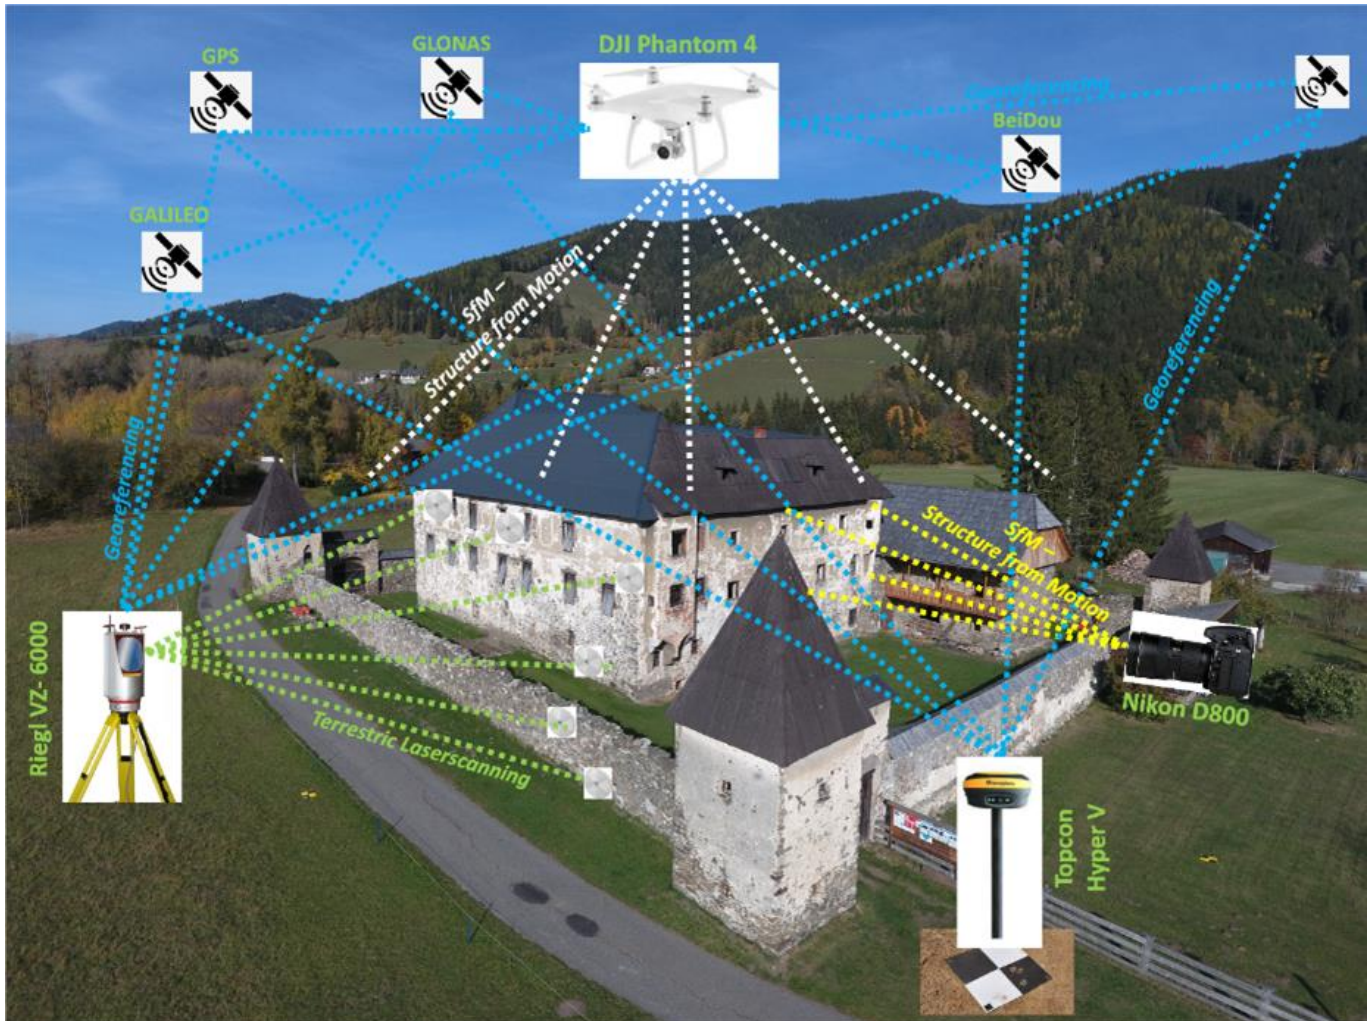
**Figure 5.** Methodology of data acquisition

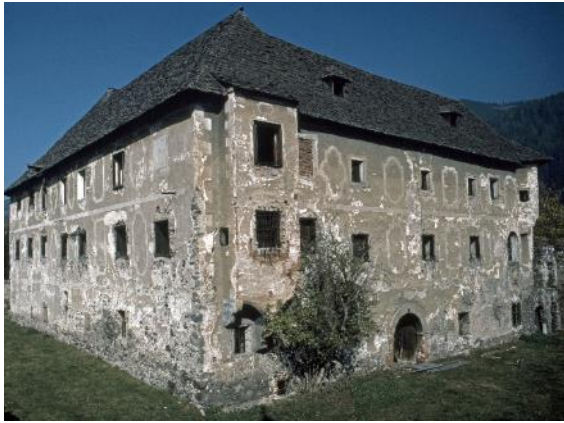
**Figure 6.** View from southwest 1986 (Photo Kaufmann)

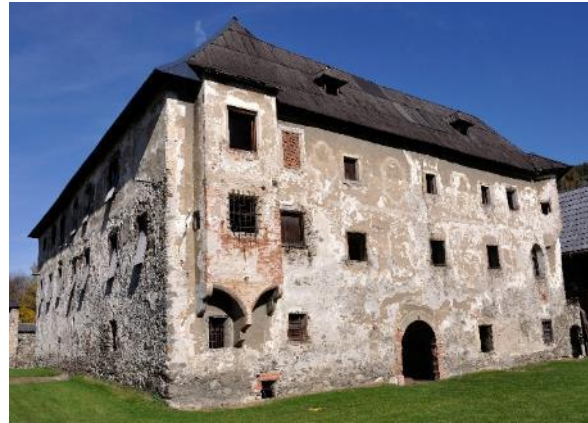
**Figure 7.** View from southwest 2019 (Photo Sulzer)

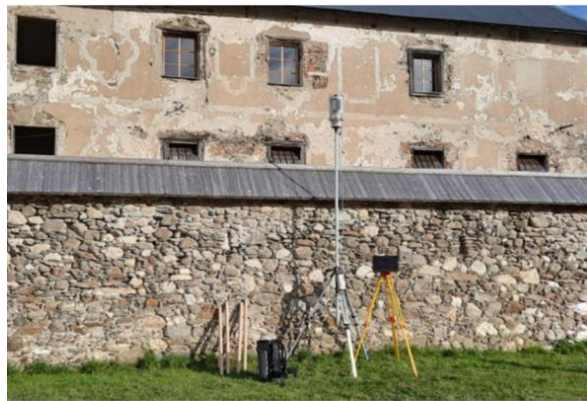
**Figure 8.** Scanning position "west façade"; the (remote-controlled) scanner is located about 10 m in front of the object at a height of 2.6 m; this does not obstruct the view

As already indicated, these parameters influence the configuration of the second group of factors. In the case of the given problem, the scanning density at the object (i.e., the façade) naturally had to be kept as high as possible (or the step size as small as possible); in order to achieve this, a balanced relationship between the scan step size to be set and the distance to the object had to be selected. Unlike in the case of long-range scans where the resulting amount of data also plays a certain role, in the present case the so-called minimum range distance is more important, the minimum distance that has to be kept in order not to destroy the receiving unit of the device. With these specifications (as little as possible more than 5 m from the façade and (for geometric reasons) as central a position as possible in front of the object), the problem arose that the surrounding wall of Hanfelden threatened to prevent the optimal positioning of the scanner or would have covered the lower parts of the building. For this reason, a telescopic tripod was used instead of the usual tripod, with the help of which the scanning platform could be raised to a height of 2.6 m, thus ensuring an unobstructed view of the entire west façade (fig. 8 and fig. 15).

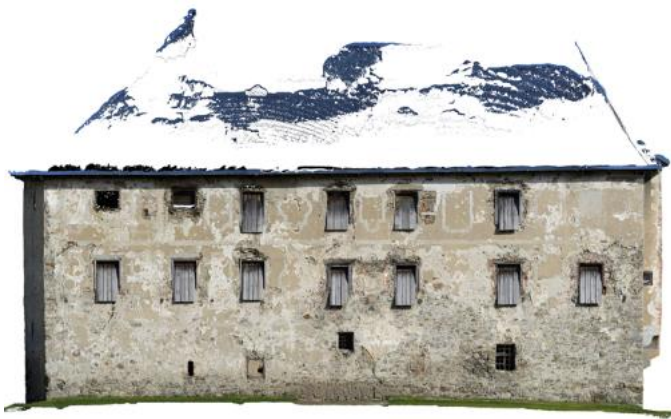
**Figure 9.** Orthophoto with an original resolution of 2mm

The Surfer software was used to create 10 orthophotos and 7 plans on a scale of 1:100 in PDF format (paper format: A3 and A4, fig. 10) for 2019. Furthermore, a virtual tour of the façade of Hanfelden Castle was created in the form of a video using the CloudCompare software from the photo-textured 3D model. The 10 resulting orthophotos of the façades of Hanfelden Castle, which were created using terrestrial photogrammetry and geodetic measurements, are in JPG format (incl. World File) and in 7 plans in PDF format (paper format: A3 and A4; scale 1: 100, fig.10) provided. The geometric resolution of the Orthophoto is 2 mm/pixel (fig. 9).

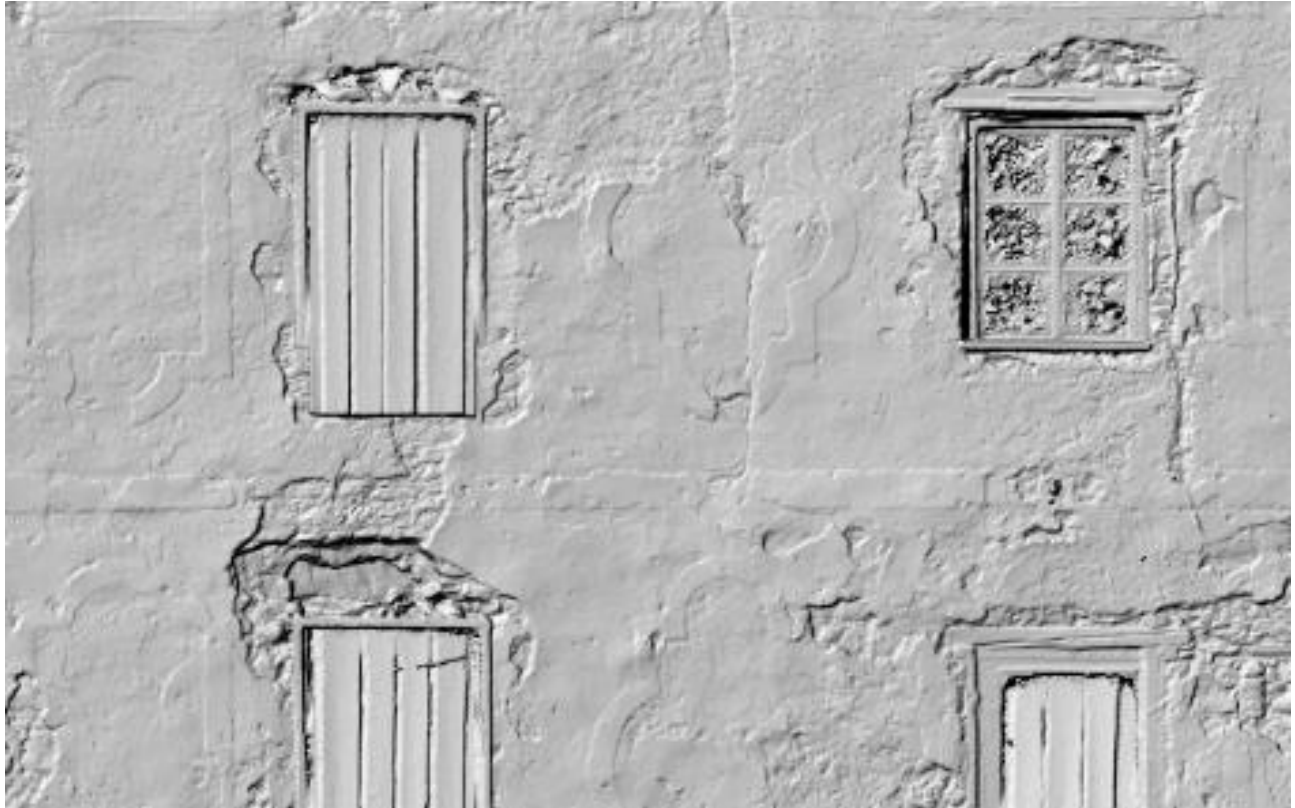
**Figure 13.** Terrestrial Laser Scanning: Digital Surface Model (DSM) from 2022 (detail)

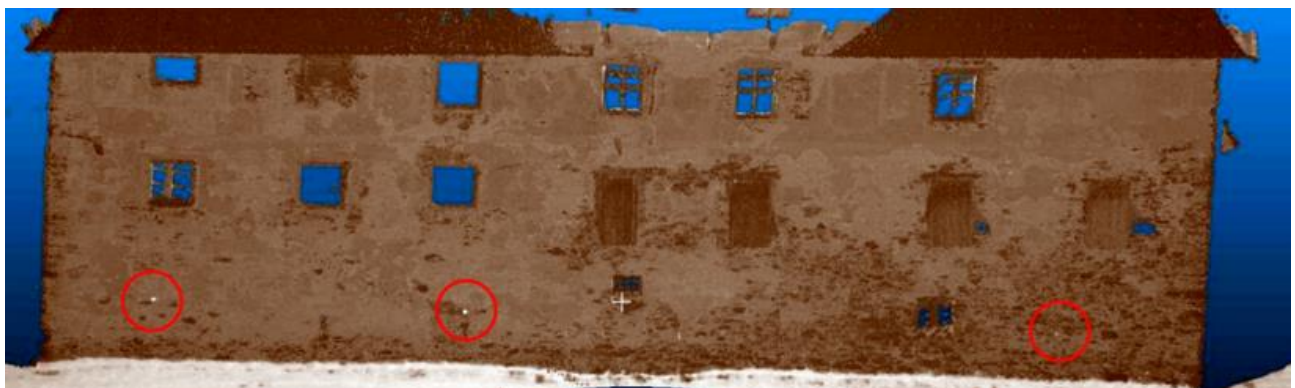
The capture (fig. 14) shows the initial scan result, the point cloud consisting of approx. 25 million points was not processed; but merely coloured to improve the display.

**Figure 14.** Raw scan of the west façade; the red circles mark the reflectors attached to the wall for georeferencing and comparison with the other partial scans
