Morphometric documentation and computer-based visualization of slope deformation and slope creep of the Blaubach landslide (Salzburg, Austria)

V. Kaufmann

Institute of Geodesy, Graz University of Technology, Austria

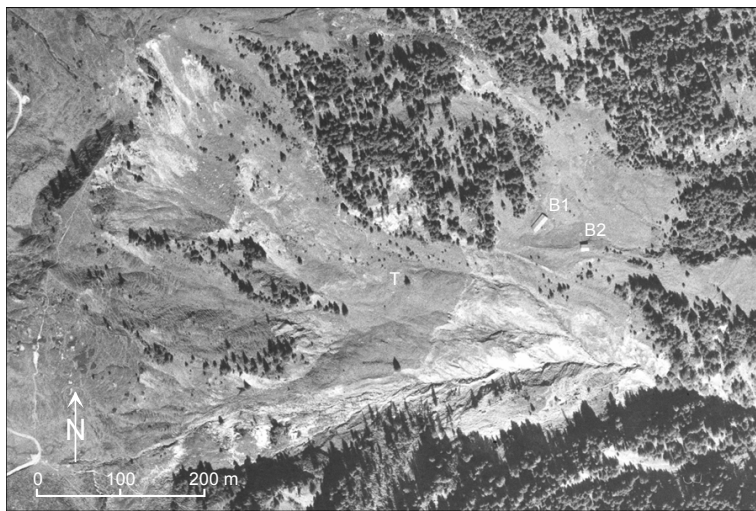
Figure 2. Orthophoto (September 13, 1999) showing the Blaubach landslide. Aerial photograph © BEV-2001, Vienna, No. 40708/01.

The Blaubach landslide (geographical position 12°08' E, 47°13' N, see Fig. 1; altitude range 1500 m – 2000 m; area 0.23 km², length 750 m) is located in the headwaters of the Blaubach torrent and comprises two creeping morphological units, which merge downslope forming a Y- shaped terrain unit (see Fig. 2). The lower part of this unit is characterized by retrogressive erosion and large mass wasting. Soil, boulders and debris are transported by run-off waters through a narrow channel into the Blaubach gorge (see Fig. 3). No forest cover, as can be seen in the surroundings of the landslide zone, has been able to develop due to the obvious high creep velocity and surface mass movements, mostly rotational landslides. Only a few trees are growing on the prevailing Alpine meadows, which are used intensively for sheep grazing. Swamps can be found in many locations. The landslide is structurally aligned along a prominent geological fault. The substrate is mainly composed of graphitic phyllites, strongly weathered schists and other tectonically fractured rocks (see ZOBL 2001). After heavy rainfall the water of the Blaubach torrent is usually of a bluish color because of its sediment load, which also explains the torrent's name (German blau = blue). Mudflows triggered by such rainfalls are a potential hazard for the inhabitants of the village of Krimml and may also damage construction works, e.g. Gerlos Alpenstrasse (scenic road) and a reservoir belonging to a hydroelectric power plant. Protective measures such as retaining walls have already been built along the Blaubach torrent. In the upper part of the torrent additional retaining structures and also debris-sorting dams are to be finished soon (see Fig. 4). Draining and afforestation of the landslide area is in the planning stage. Despite the fact that investigations have been carried out on the present landslide over a period of many years no quantitative information, e.g. on creep velocity or volumetric change, is available for authorities, planners and decision makers.

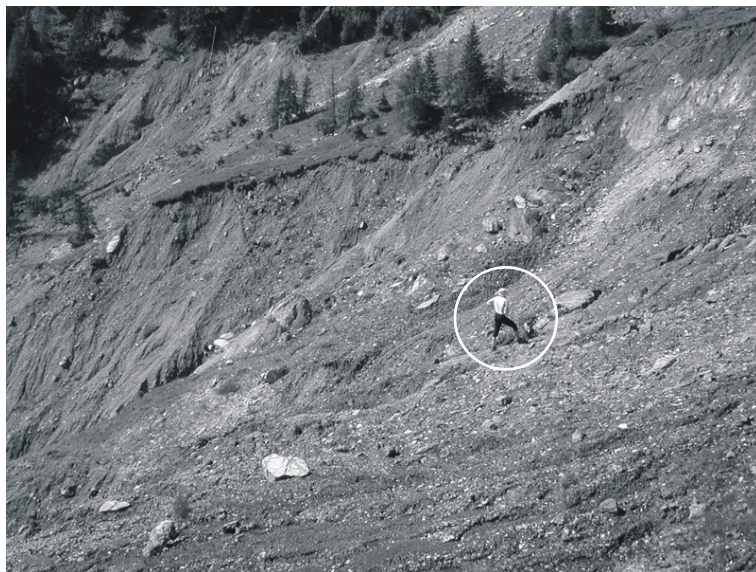
Figure 3. The lower part (foot) of the Blaubach landslide is characterized by large mass wasting. Note person (within white circle) for scale. Photograph taken July 4, 2001.

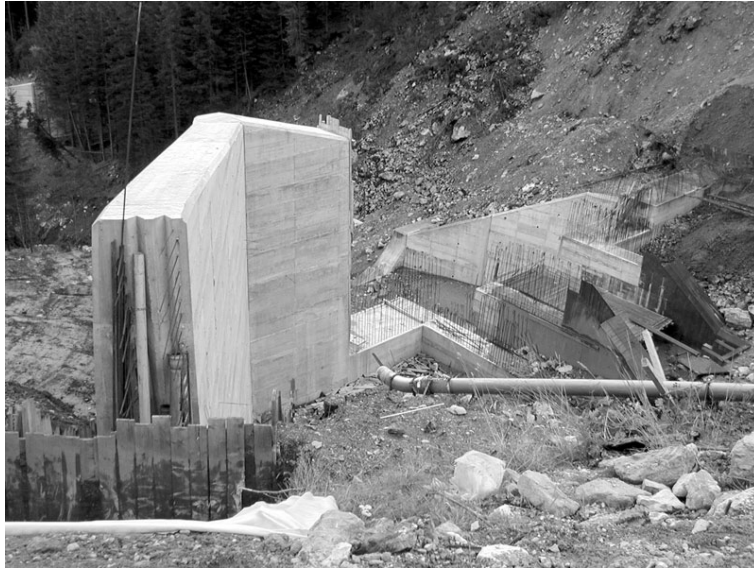
Figure 4. Retaining walls and debris-sorting dams are built along Blaubach torrent as a protective measure. Photograph taken October 23, 2000.

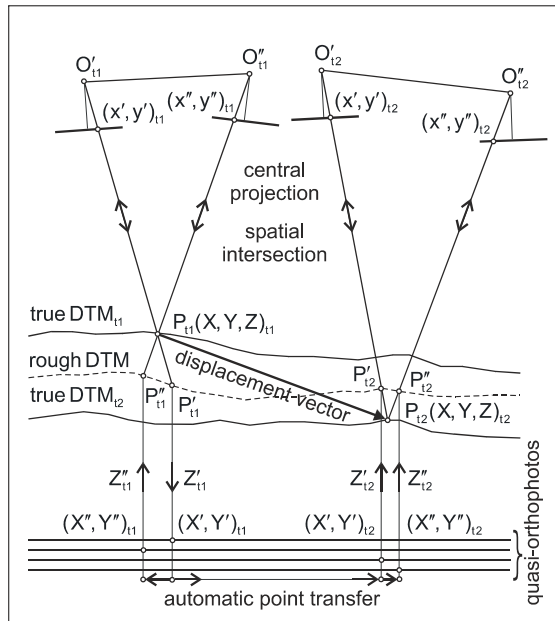
Figure 5. Basis concept of the automatic measurement of 3-D displacement vectors in digital multi-temporal photographs. Detailed explanations of this concept are given in KAUFMANN & LADSTÄDTER 2002.

Aerial photographs of 11 different data acquisition periods between 1953 and 1999 were acquired from the Austrian Federal Office of Surveying and Mapping, Vienna (Table 1). Image scales vary between 1:9,300 and 1:45,800. In order to support methodological questions the evaluation of the multi-temporal photographs was carried out using the analytical plotter DSR-1 of Kern and the digital photogrammetric workstation ISSK of Z/I Imaging. High-quality image scans were made available through Vexcel Imaging Austria, Graz, using the UltraScan5000 (GRUBER & LEBERL 2001). High-resolution digital terrain models with a grid spacing of 1 meter were obtained for all periods, thus facilitating the computation of the changes in surface height and volume of the landslide in the course of the past 46 years. Maximum changes in surface height due to surface deformation were measured at +10.0 m and -15.0 m, respectively. The volumetric changes in the 1990s suggest a mean annual sediment load of 12,000 m³/year as an input to the Blaubach torrent. The results obtained clearly show the course of vertical slope deformation and, especially, the increase of mass wasting in the southern branch of the landslide and also in the badland-type areas at the foot of the mass movement during the last decade. ADVN software, originally developed at the Institute of Geodesy for monitoring debris-covered glaciers and rock glaciers, was used to automatically derive three-dimensional displacement vectors based on image matching techniques (cp. Fig. 5). An average of 39,900 displacement vectors were obtained for all calculated time periods (see Fig. 6, compare with CUNIETTI et al. 1984). Numerical (mean annual horizontal creep velocities) and graphical (flow/creep velocity fields) representations of the results obtained show that the landslide was active throughout the observed time span, with maximum creep velocities of up to 1.6-1.8 m/year for the time period 1953-1962. For 1991-1999 a maximum creep velocity of 1.3 m/year was measured, whereas the terrain above the main scarp of the retrogressive erosion zone moved downslope at a rate of 1.1 m/year in horizontal direction (see Fig. 7). Despite changes in long-term creep velocity due to sudden surface landslides and annually changing creep velocities, the creep velocities observed are quite uniform (secondary creep) over time. Shear zones (moving/non-moving) can be clearly identified at the outer margins of the landslide. The results of the digital photogrammetric evaluation were checked by means of conventional photogrammetric measurements through an operator tracking individual trees riding on top of the mass movement. For example, a horizontal movement of 53.9 m was measured for a single tree (position T in Fig. 2) for the time period 1953-1999. Significant movements of two buildings (positions B1 and B2 in Fig. 2) situated directly outside the main sliding area were also detected, with annual horizontal displacements amounting to 4.2 cm.

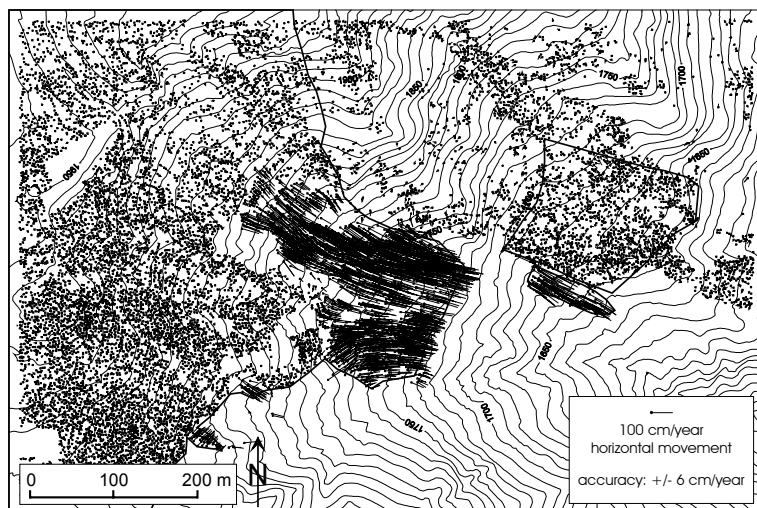
Figure 6. Flow vector field (displacement vectors) at Blaubach landslide for the time period 1991-1999. Three selected areas for further analysis are outlined.

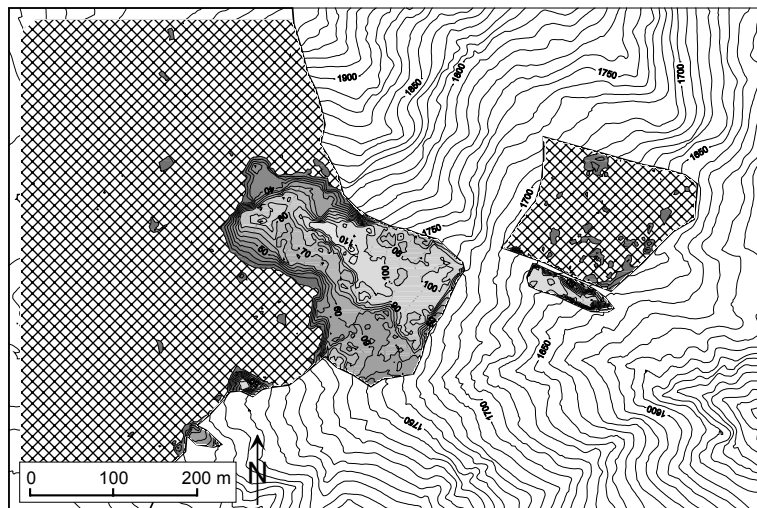
☒ photogrammetrically non-significant movement

Figure 7. Mean annual horizontal flow/creep velocity at Blaubach landslide for the time period 1991-1999. Numbering of isotachs is given in cm/year.

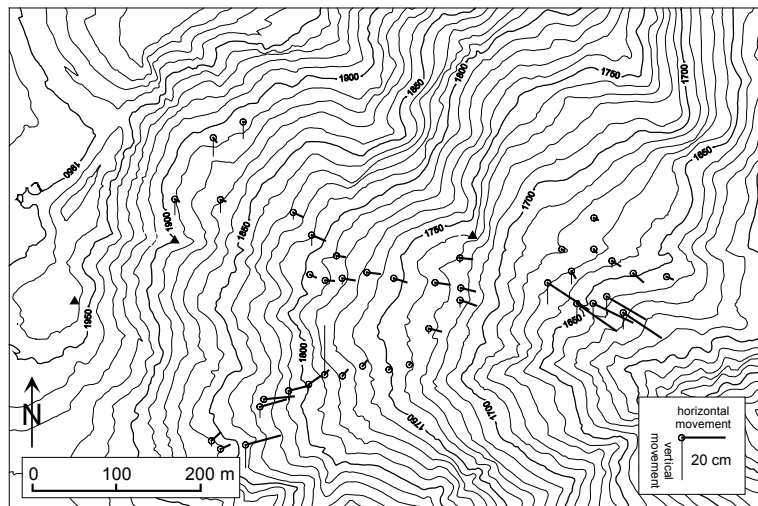
Figure 8. Horizontal and vertical displacement vectors derived from geodetic measurements for the time period July - October 2001.

A geodetic observation network consisting of several non-moving reference points outside the moving terrain and 41 observation points evenly distributed inside the landslide area was set up for high-precision deformation measurements in June 2001. Due to the very soft substrate of the landslide all observation points were stabilized with 1.5 m long iron rods. The absolute orientation of the network was derived from differential GPS (Global Positioning System) measurements. However, all observation points were measured using an electronic theodolite (Total Station). Two surveys of the network were carried out in 2001, i.e. in July and October. Maximum horizontal displacements of up to 23 cm were obtained (see Fig. 8). However, after scaling these data to annual values, the extrapolated creep velocities were four times smaller than anticipated from the photogrammetric measurements. It is assumed that seasonally changing precipitation caused the observed short-time change of activity of the
